Roughness Characteristics of Natural Channels

U.S. GEOLOGICAL SURVEY WATER-SUPPLY PAPER 1849

*Color photographs and descriptive
data for 50 stream channels for
which roughness coefficients have
been determined*

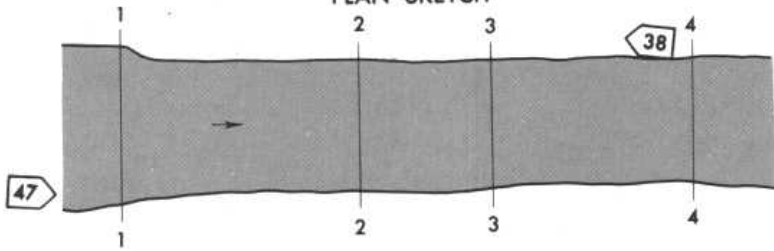
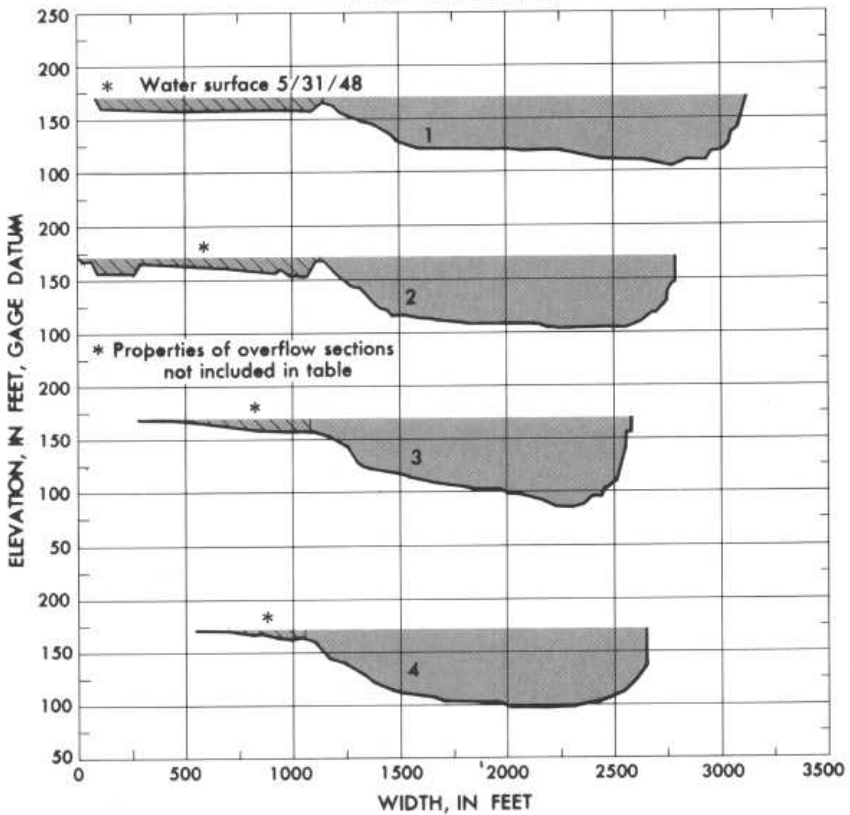
Plan sketch and cross sections, Columbia River at
The Dalles, Oreg.

Description of channel.—Left bank consists of sand, gravel, and boulders, and has light cover of brush in some places. Right bank is formed by severely scalloped basalt cliffs. The bed material is fairly well graded from 18-inch boulders along the left bank down to sand at the base of the right bank.

Section	Area (sq ft)	Top width (ft)	Mean depth (ft)	Hydraulic radius (ft)	Mean velocity (ft per sec)	Length (ft) between sections	Fall (ft) between sections
1.....	94,650	1,980	47.80	47.28	10.57
2.....	90,810	1,640	55.37	54.10	11.01	2,003	0.50
3.....	89,040	1,485	59.96	57.80	11.23	778	.20
4.....	91,890	1,600	57.43	55.81	10.88	1,394	.41

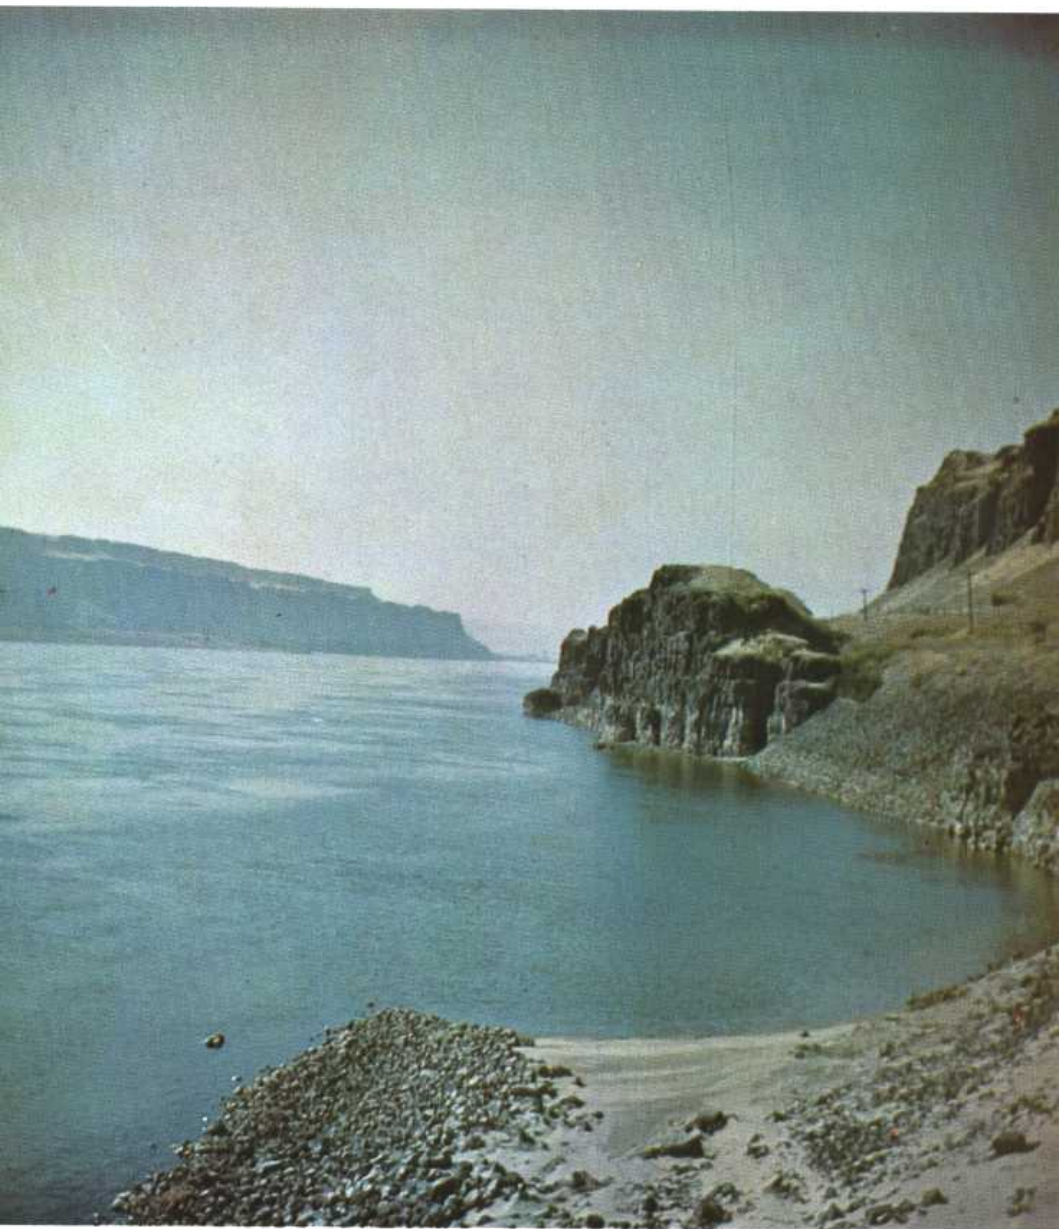
No. 47 downstream along right bank from above section 1,
Columbia River at The Dalles, Oreg.

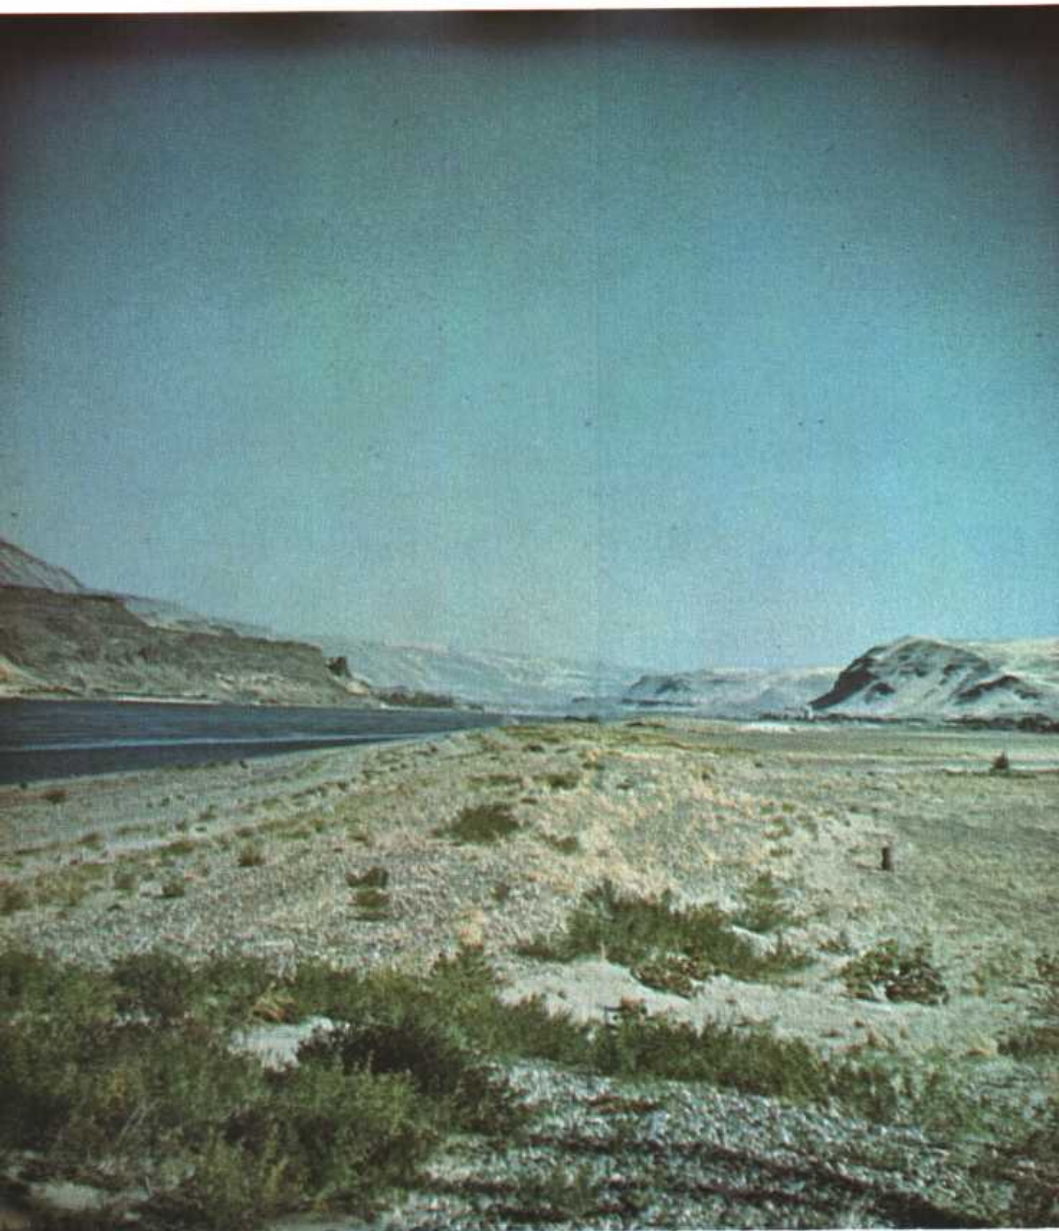
No. 38 upstream along left bank from section 4,
Columbia River at The Dalles, Oreg.

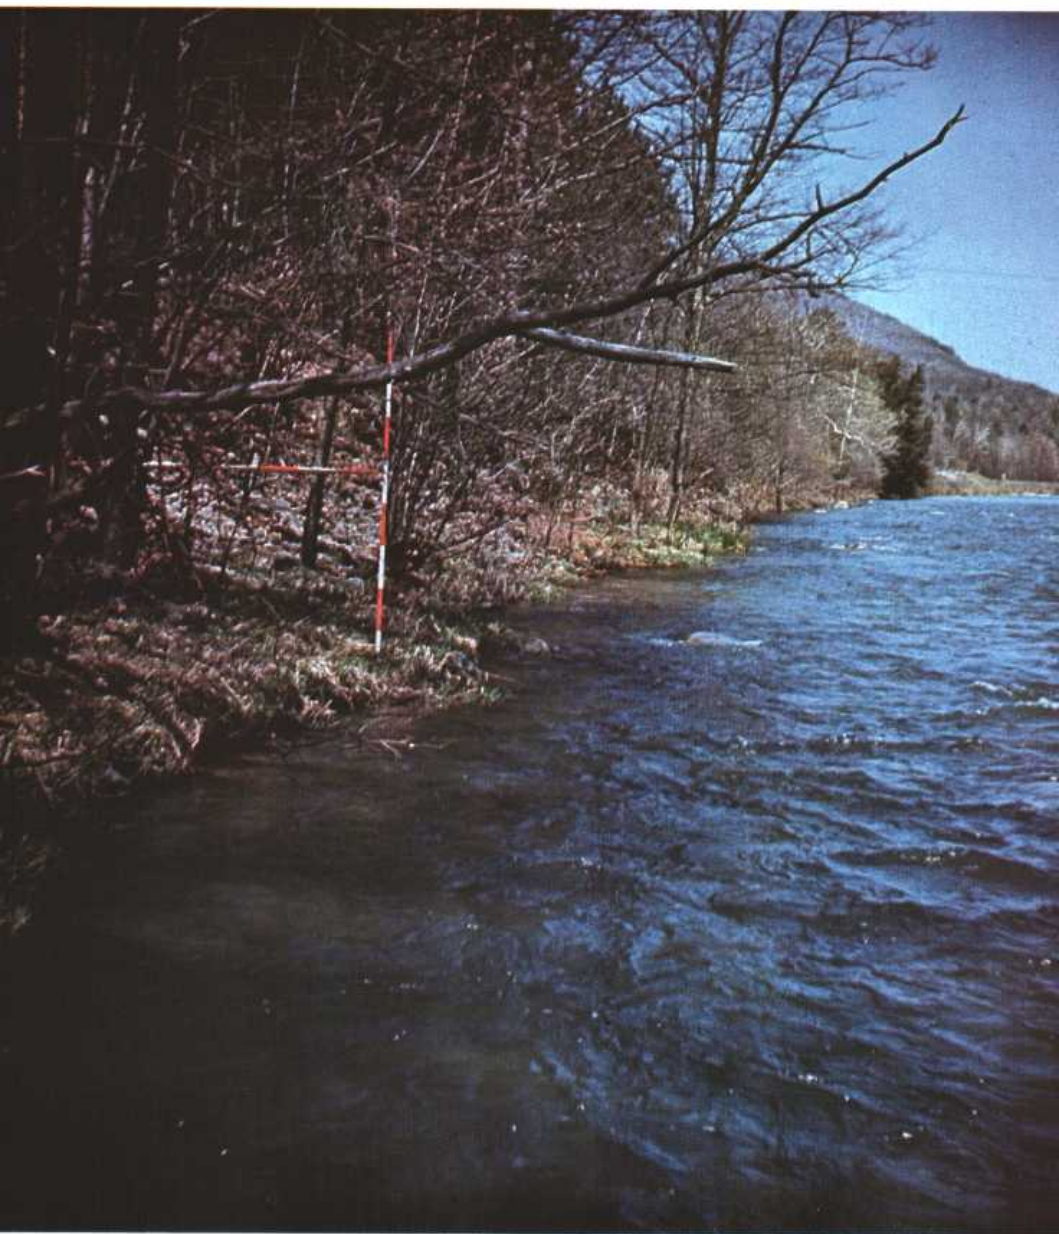
No. 354 upstream along left bank from section 2,
Esopus Creek at Coldbrook, N.Y.

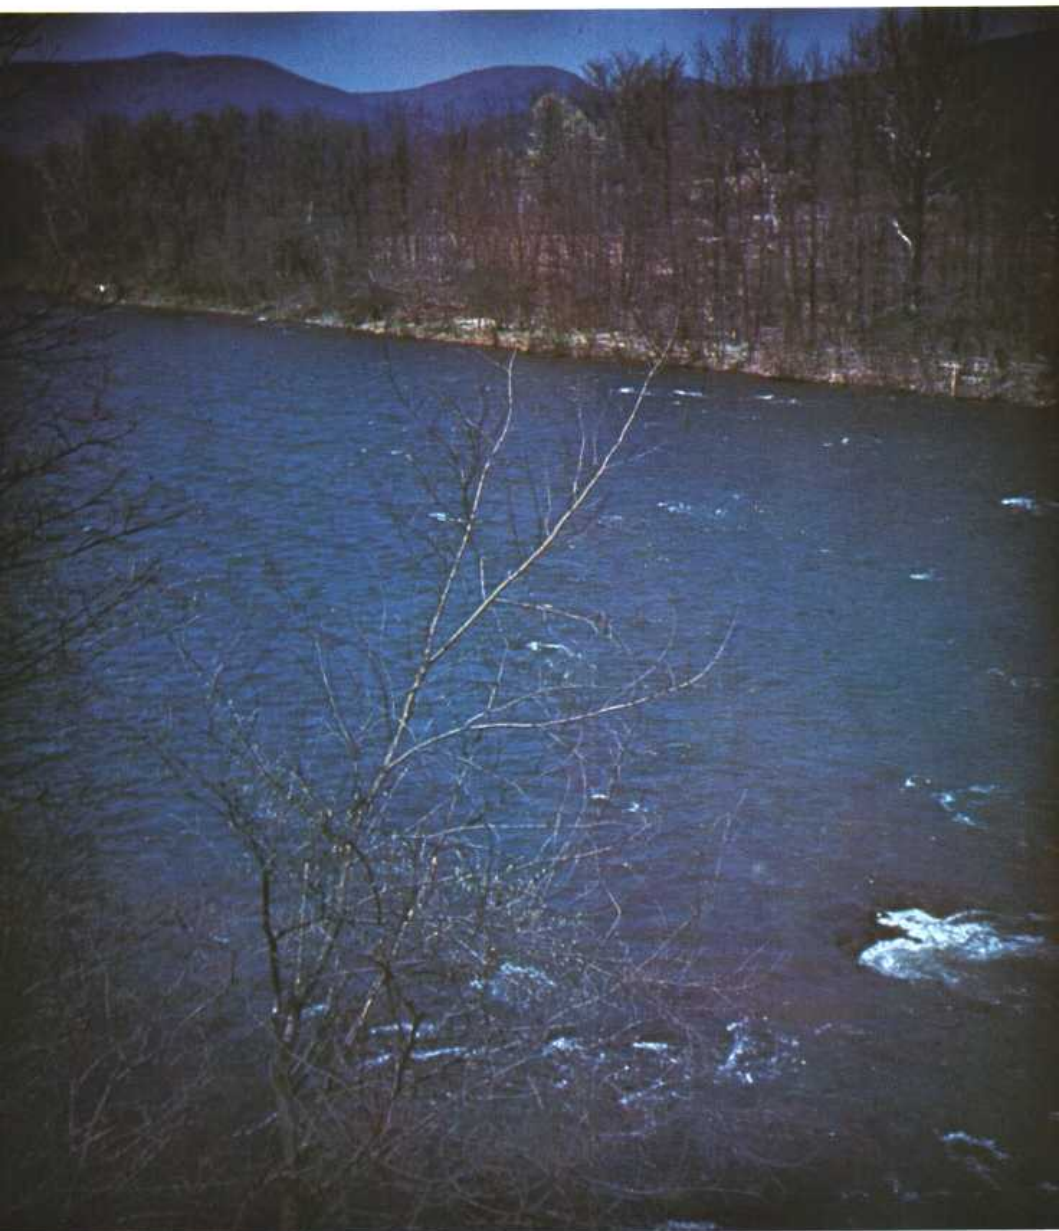
No. 357 upstream from right end of bridge below reach,
Esopus Creek at Coldbrook, N.Y. (at Highway 28-A).

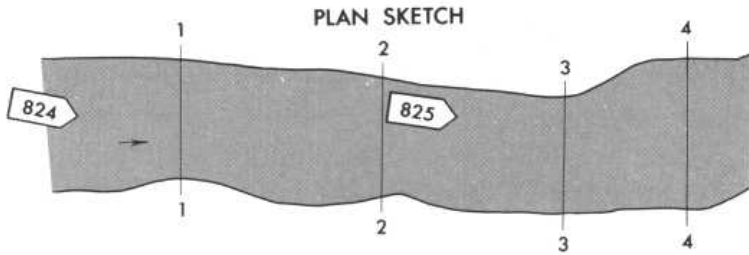
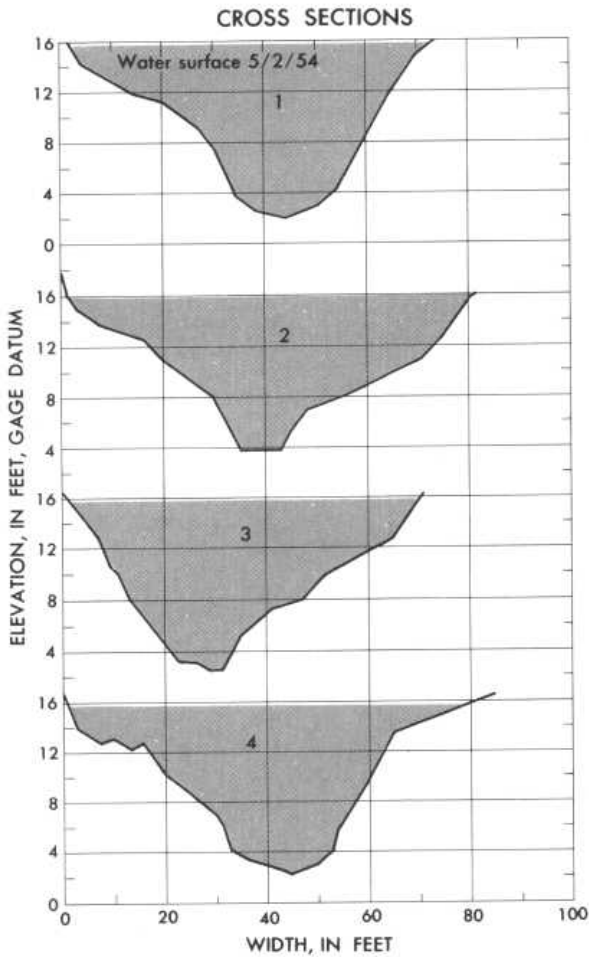
Plan sketch and cross sections, Salt Creek at Roca, Nebr.

Description of channel.—Bed consists of sand and clay. Banks are generally smooth and are free of vegetal growth during floods.

Section	Area (sq ft)	Top width (ft)	Mean depth (ft)	Hydraulic radius (ft)	Mean velocity (ft per sec)	Length (ft) between sections	Fall (ft) between sections
1.....	528	72	7.4	6.7	3.46
2.....	502	80	6.3	5.9	3.71	113	0.09
3.....	497	69	7.2	6.6	3.74	110	.06
4.....	497	78	6.4	5.9	3.74	134	.05

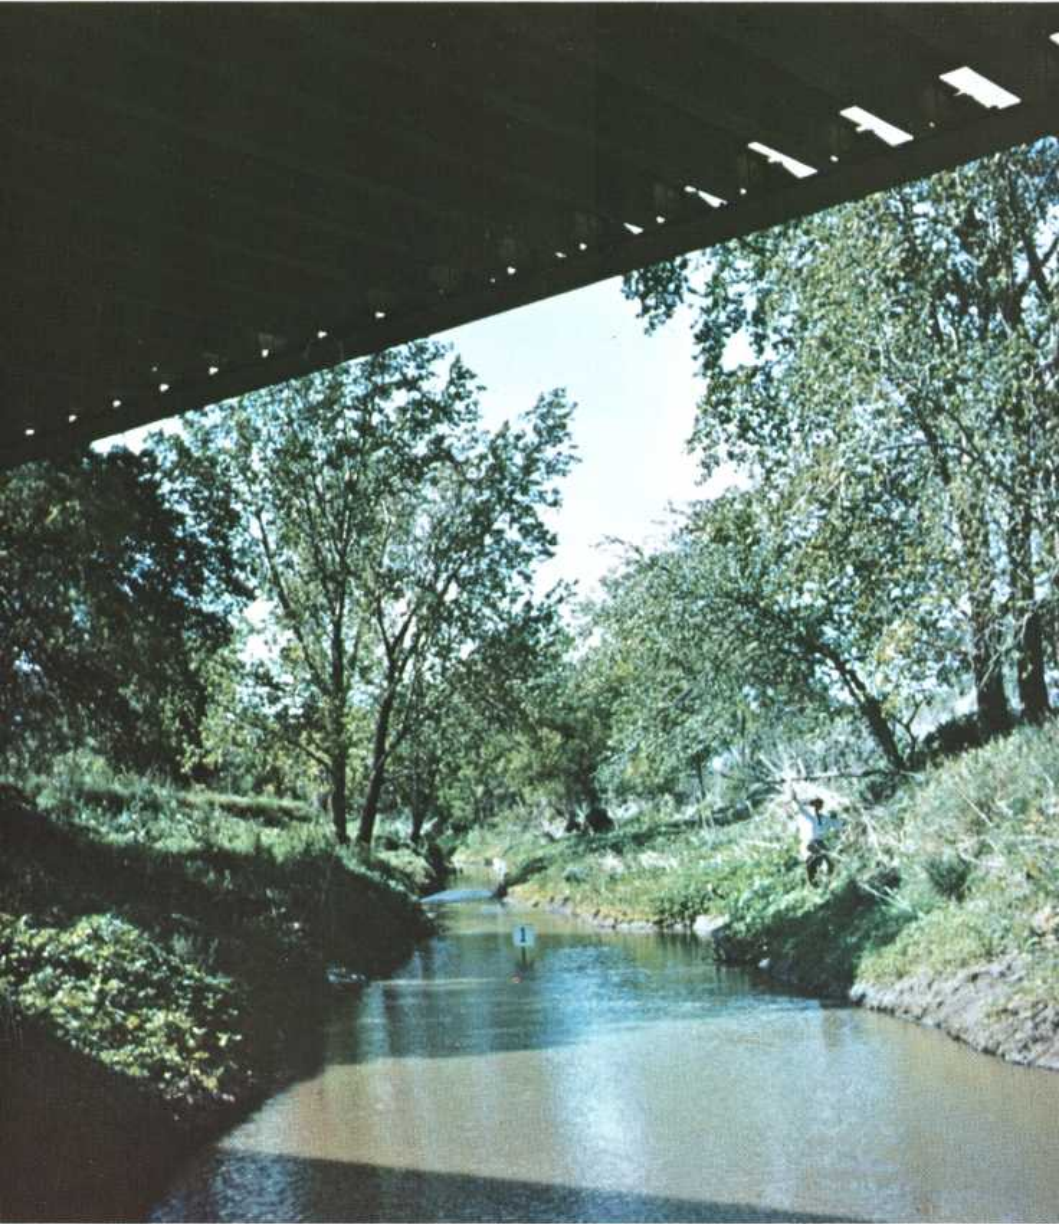
No. 824 downstream from above section 1,
Salt Creek at Roca, Nebr.

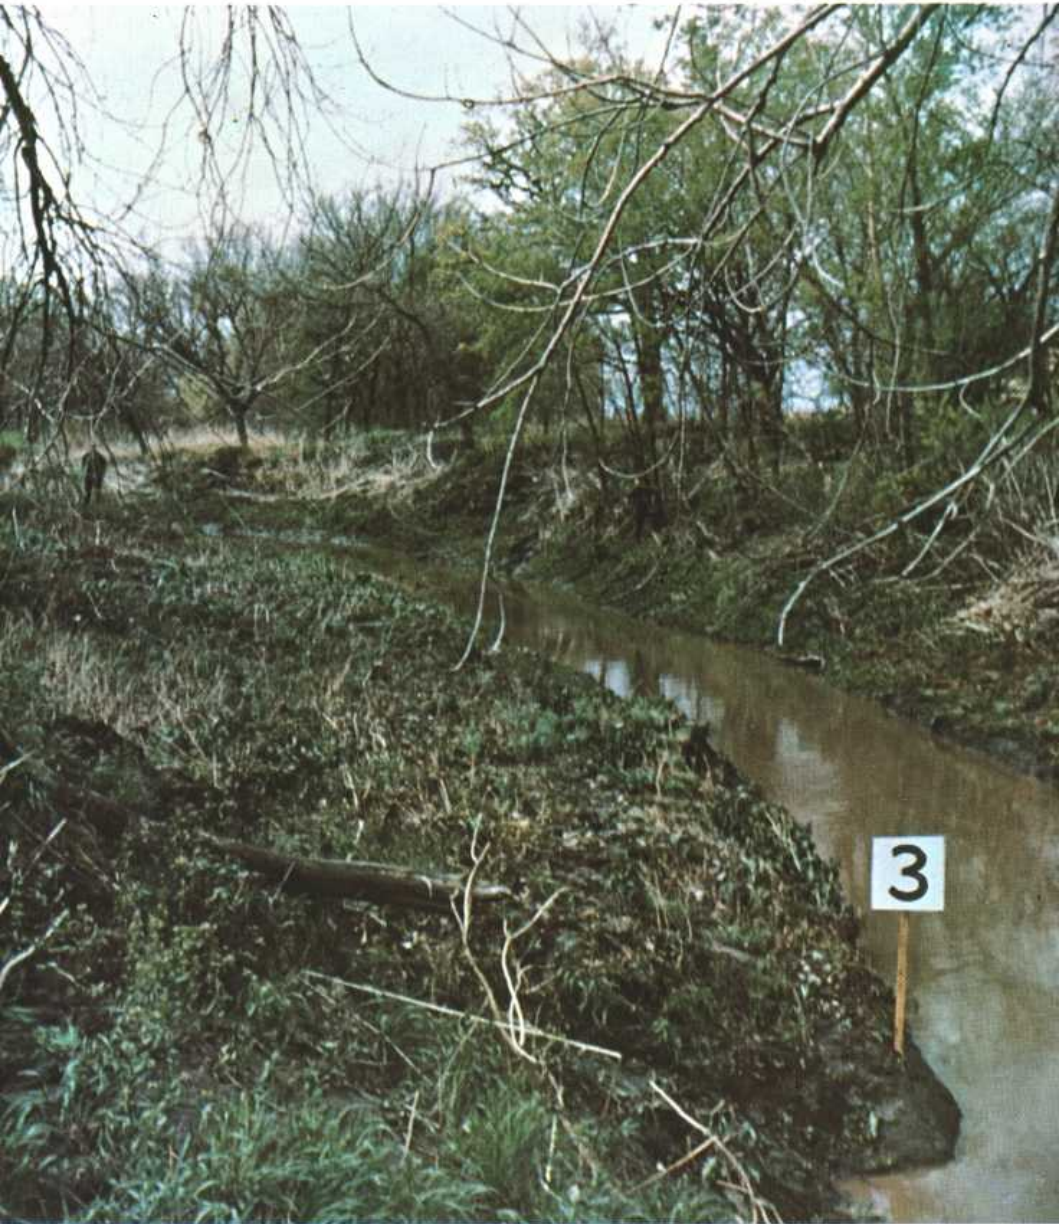
No. 825 downstream from below section 2,
Salt Creek at Roca, Nebr.

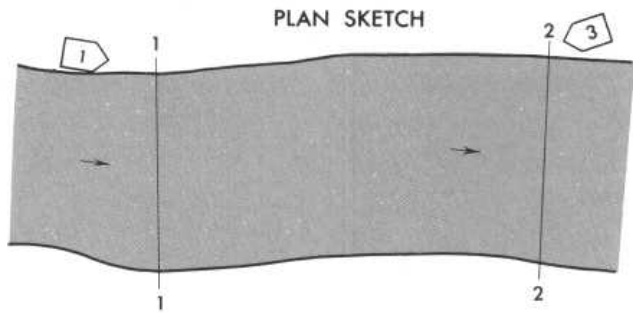
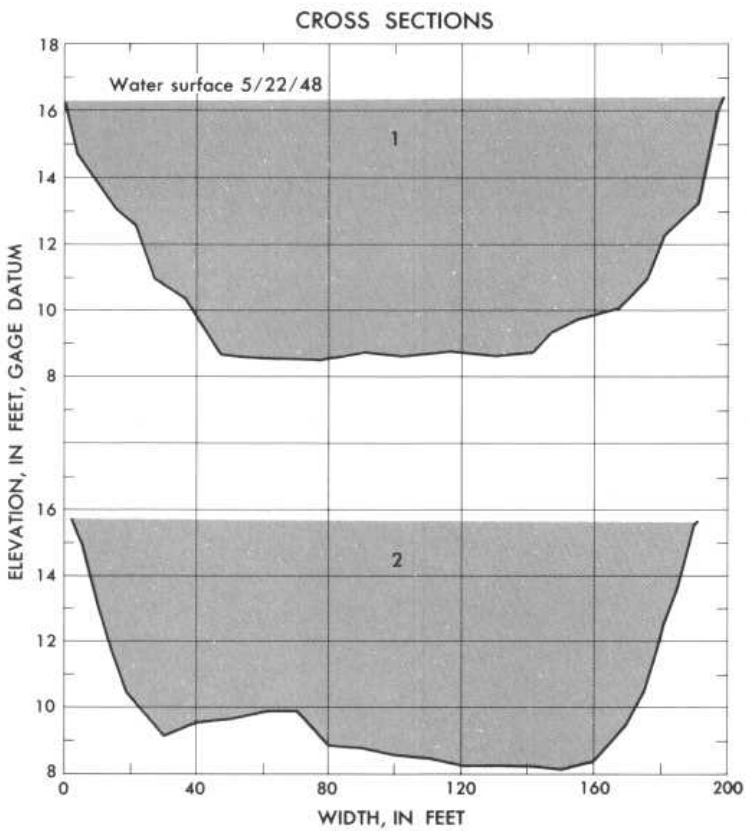
Plan sketch and cross sections, Blackfoot River near Ovando, Mont.

Description of channel.—Bed is gravel and boulders; $d_{50} = 155$ mm, $d_{84} = 280$ mm. Banks consist of same material and are relatively free of vegetation.

Section	Area (sq ft)	Top width (ft)	Mean depth (ft)	Hydraulic radius (ft)	Mean velocity (ft per sec)	Length (ft) between sections	Fall (ft) between sections
1.....	1,230	199	6.18	6.12	6.67
2.....	1,140	189	6.03	5.97	7.19	292	0.68

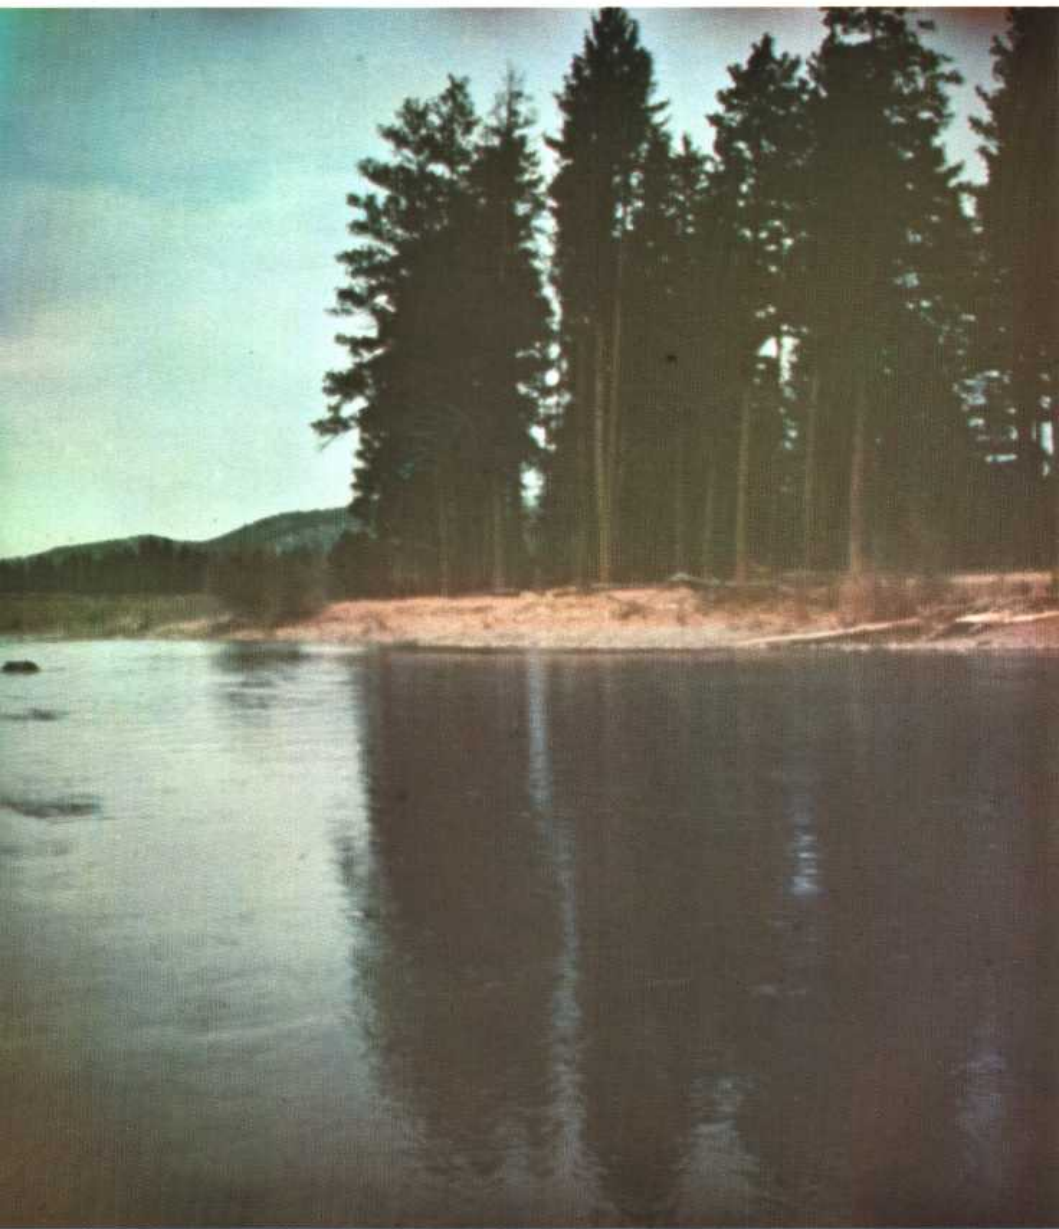
No. 1 downstream from left bank above section 1,
Blackfoot River near Ovanda, Mont.

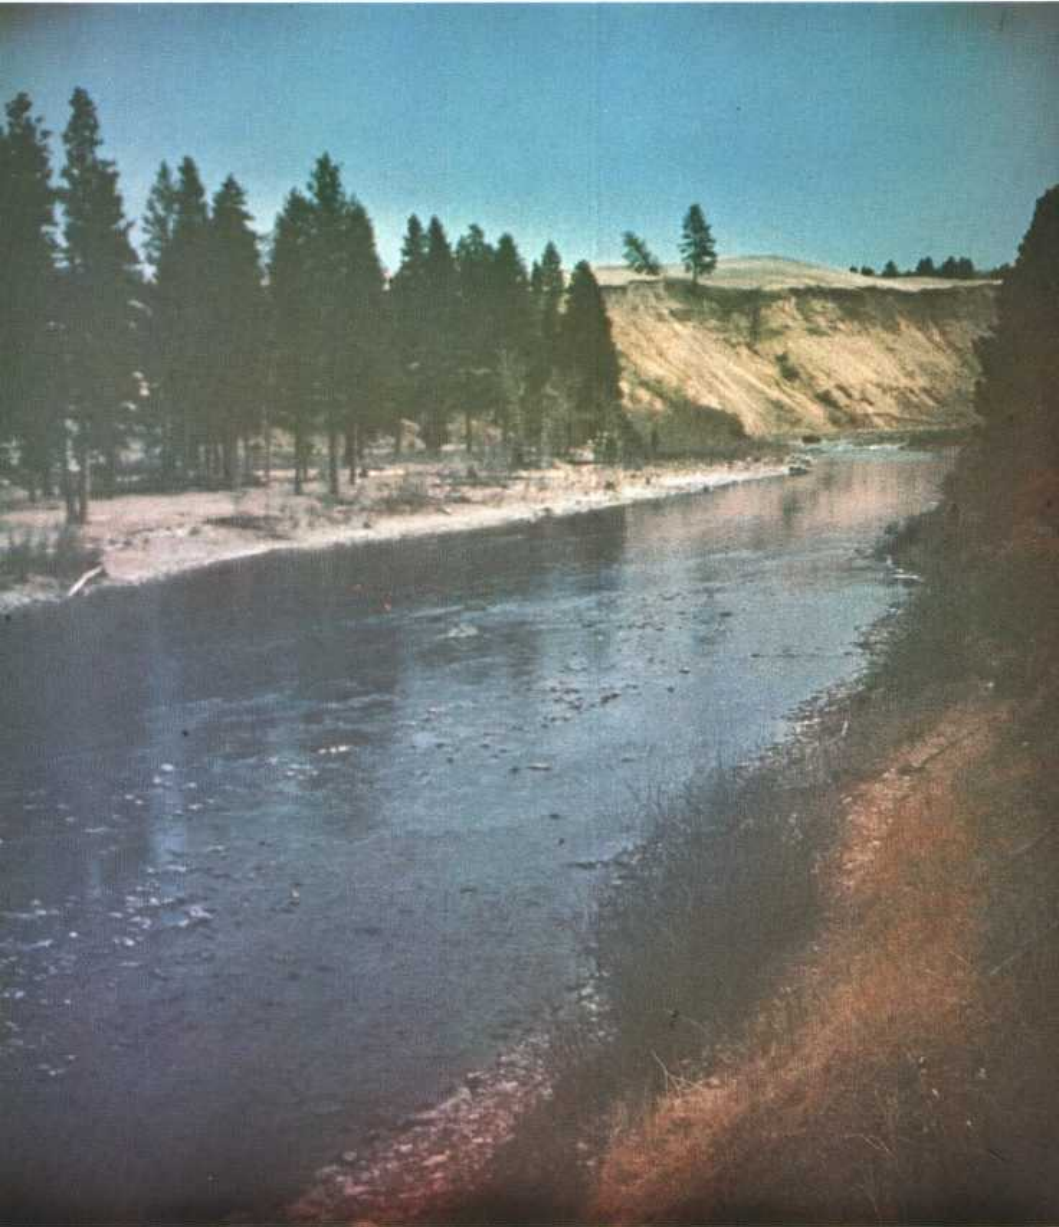
No. 3 upstream towards right bank from below section 2,
Blackfoot River near Ovanda, Mont.

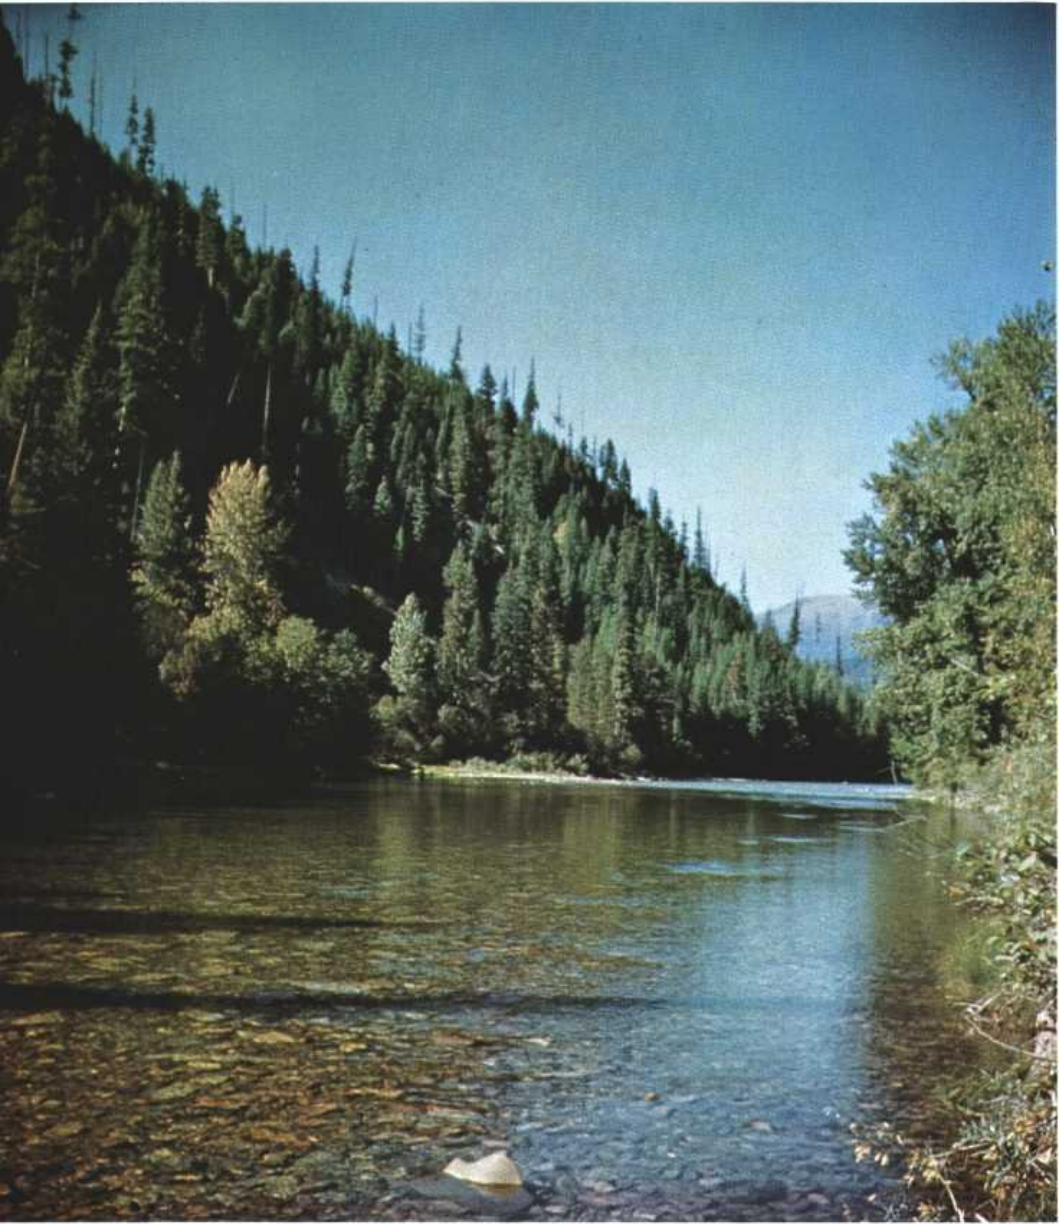
No. 34 downstream through reach from right bank,
Coeur d'Alene River near Prichard, Idaho.

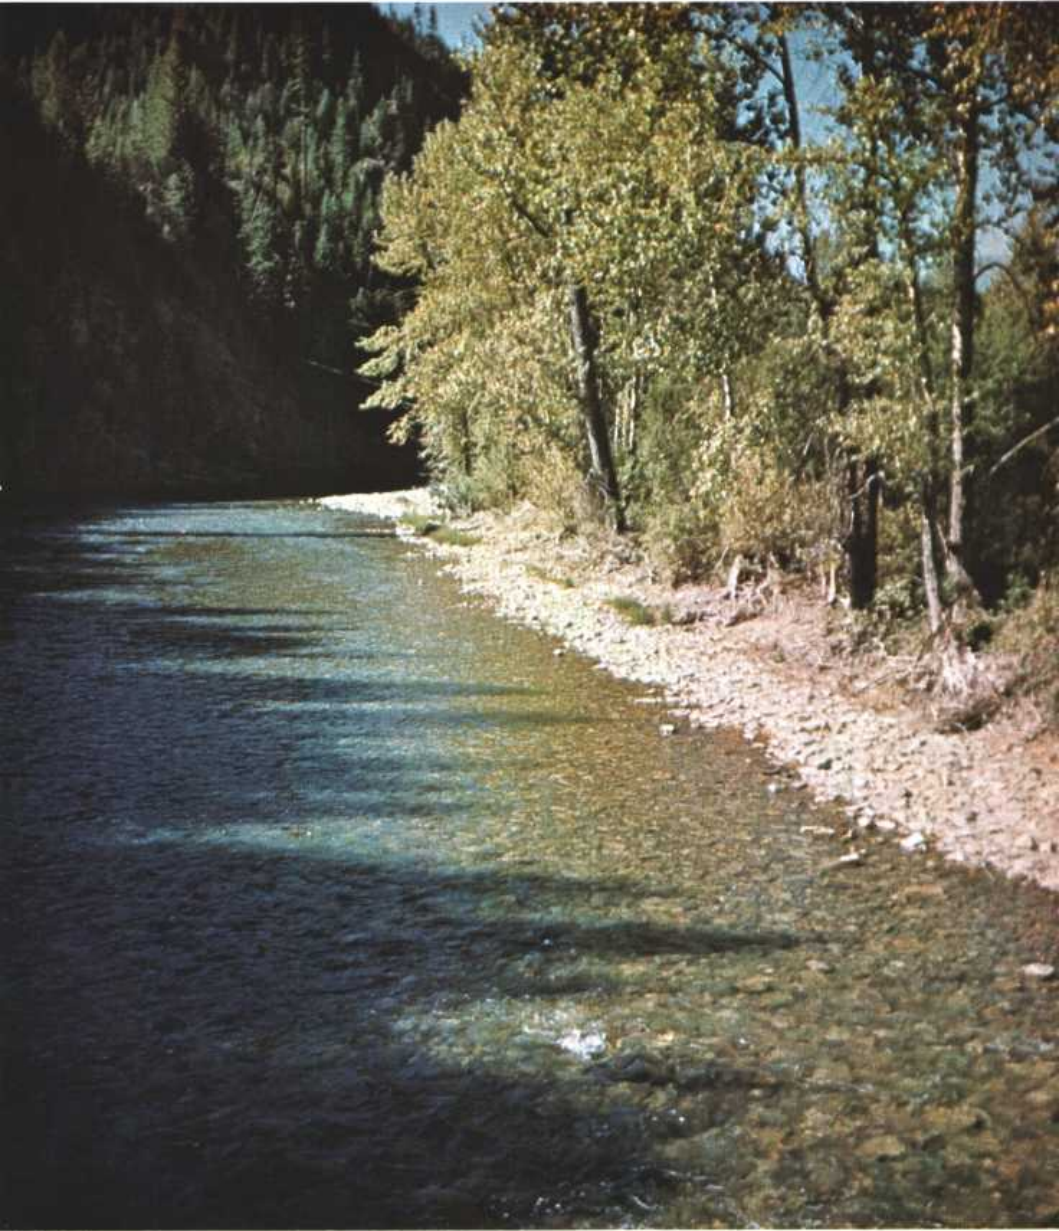
No. 36 downstream along right bank at section 1,
Coeur d'Alene River near Pritchard, Idaho.

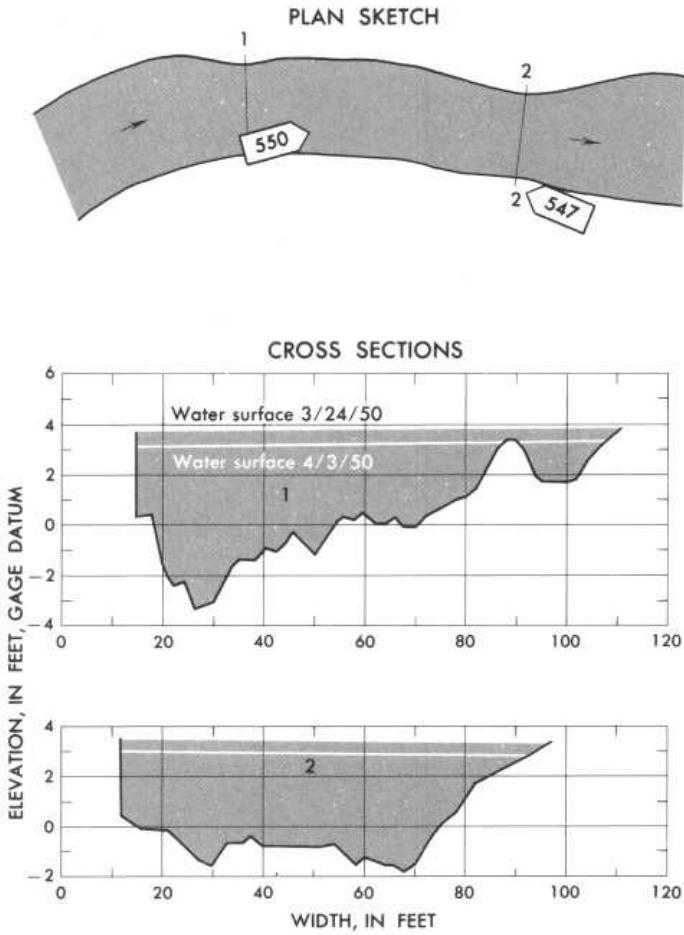
Plan sketch and cross sections, Rio Chama near Chamita, New Mex.

Description of channel.—The bed consists of sand and gravel.

The left bank is rock and the right bank is mostly gravel.

Section	Area (sq ft)	Top width (ft)	Mean depth (ft)	Hydraulic radius (ft)	Mean velocity (ft per sec)	Length (ft) between sections	Fall (ft) between sections
Mar. 24, 1950							
1	312	95	3.3	3.12	3.40
2	297	84	3.5	3.45	3.57	202	0.24
Apr. 3, 1950							
1	235	92	2.6	2.52	2.91
2	249	81	3.1	2.95	2.75	202	0.23

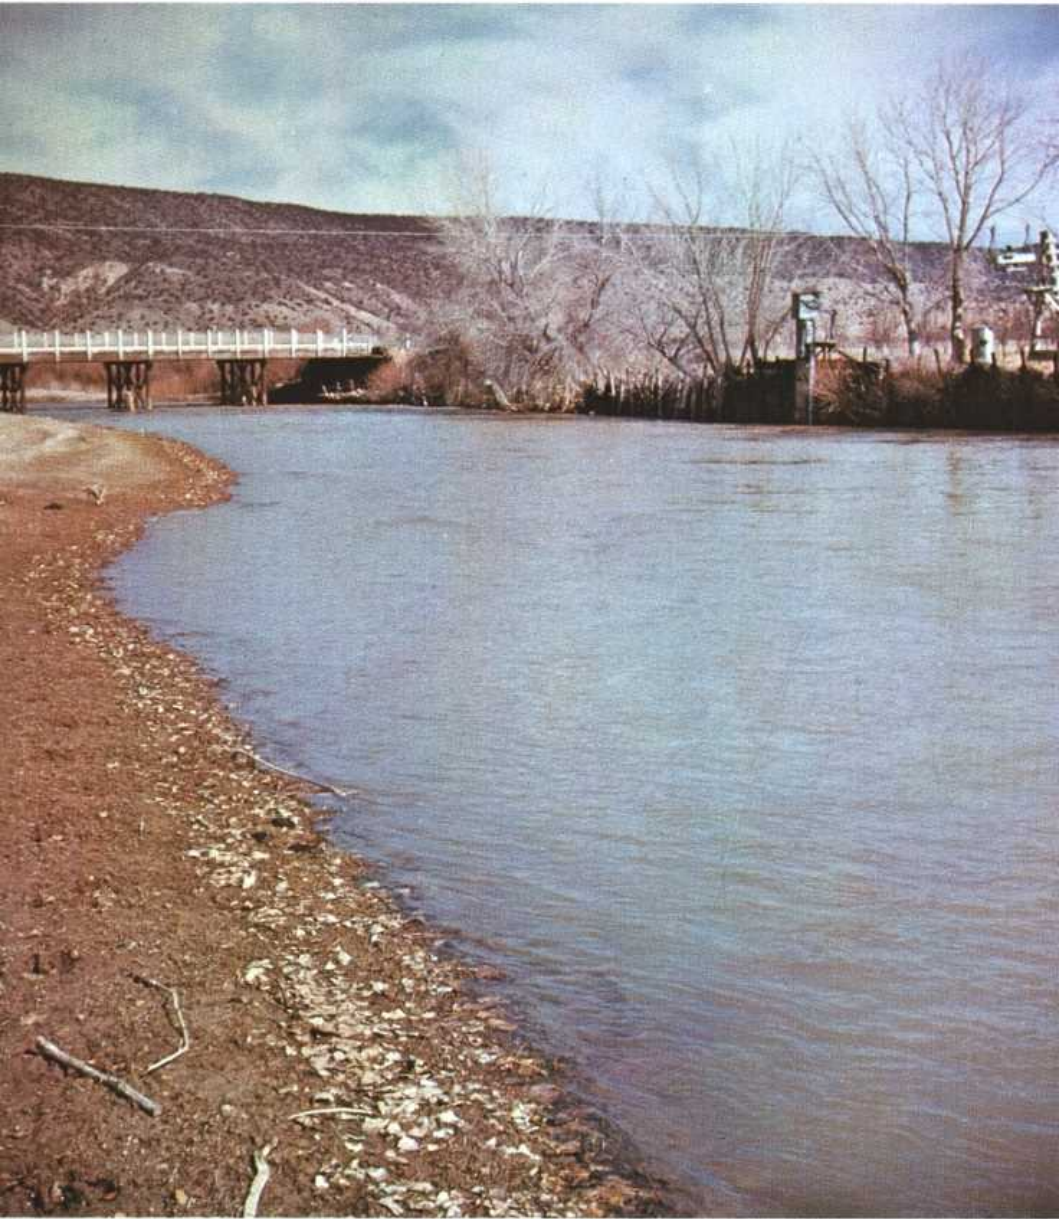
No. 547 upstream along right bank from below section 2,
Rio Chama near Chamita, N. Mex.

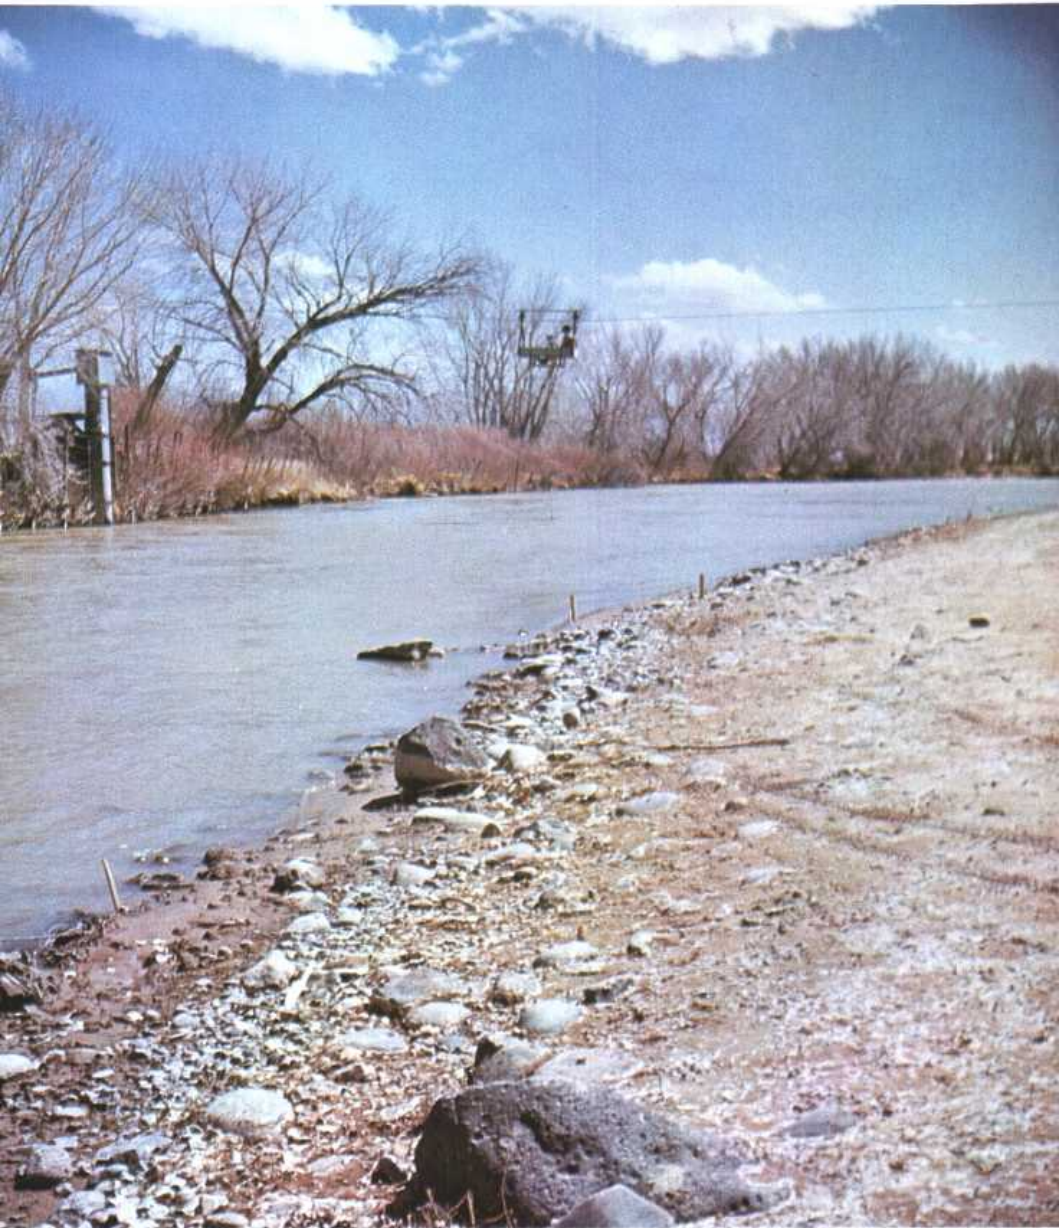
No. 550 downstream from right bank at section 1, Rio Chama
near Chamita, N. Mex.

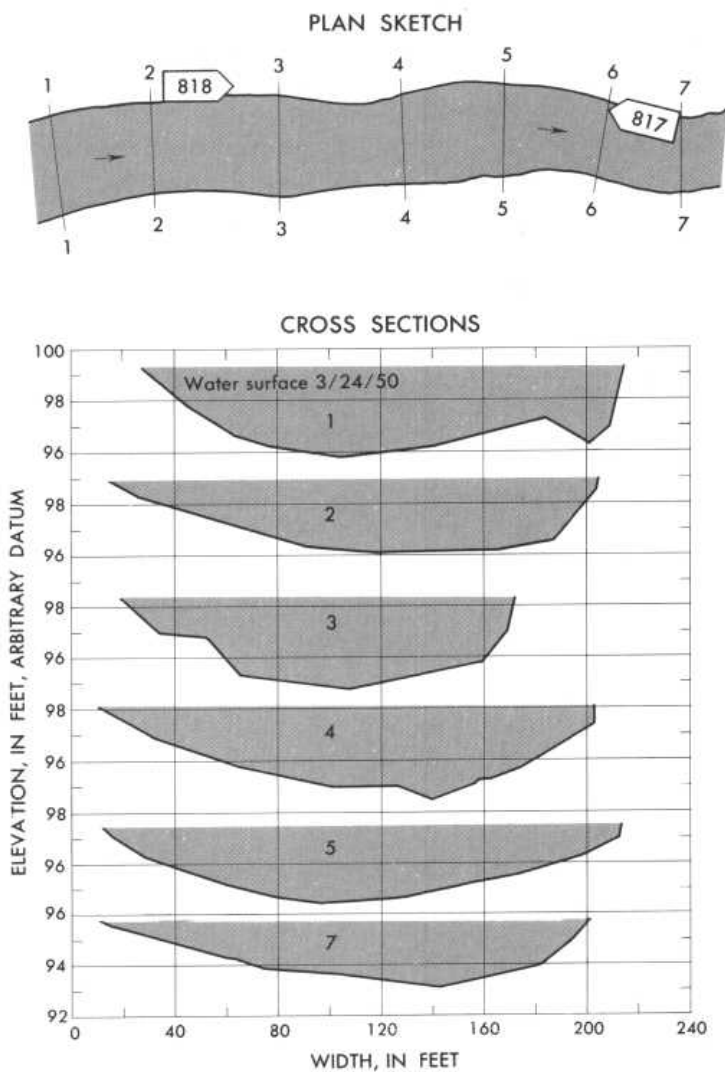
Plan sketch and cross sections, Salt River below Stewart Mountain Dam, Ariz.

Description of channel.—Bed and banks consist of smooth cobbles 4 to 10 inches in diameter, average diameter about 6 inches. A few boulders are as much as 18 inches in diameter.

Section	Area (sq ft)	Top width (ft)	Mean depth (ft)	Hydraulic radius (ft)	Mean velocity (ft per sec)	Length (ft) between sections	Fall (ft) between sections
1	484	189	2.6	2.55	2.65
2	408	192	2.1	2.12	3.14	258	0.37
3	384	154	2.6	2.49	3.34	317	.50
4	449	194	2.3	2.30	2.86	294	.31
5	420	204	2.1	2.06	3.05	370	.63
6	381	207	1.8	1.84	3.36	333	.72
7	308	191	1.6	1.61	4.16	314	1.06

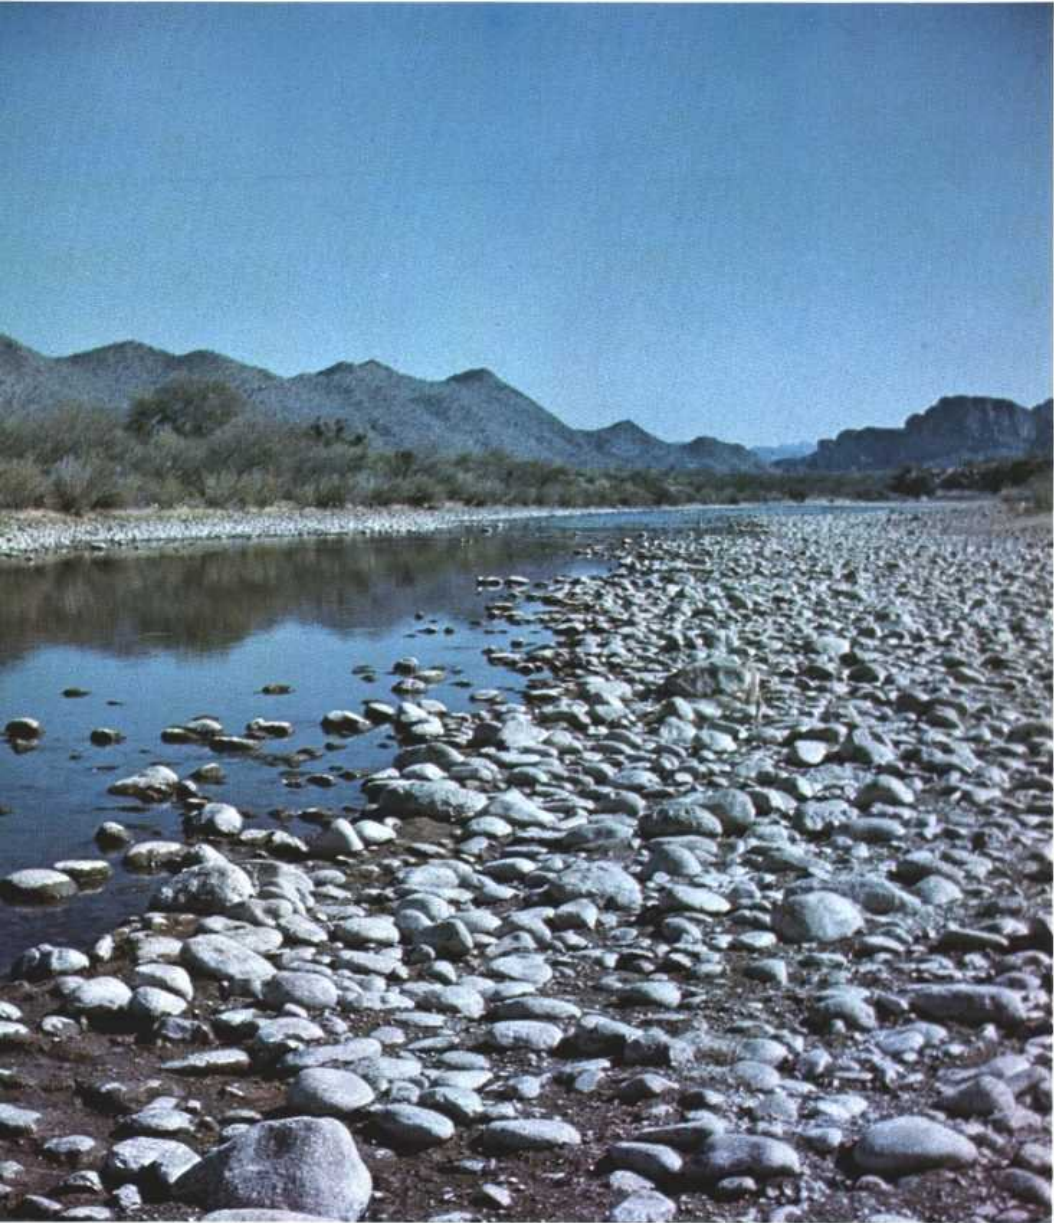
No. 817 upstream along left bank from below section 6
Salt River below Stewart Mountain Dam, Ariz.

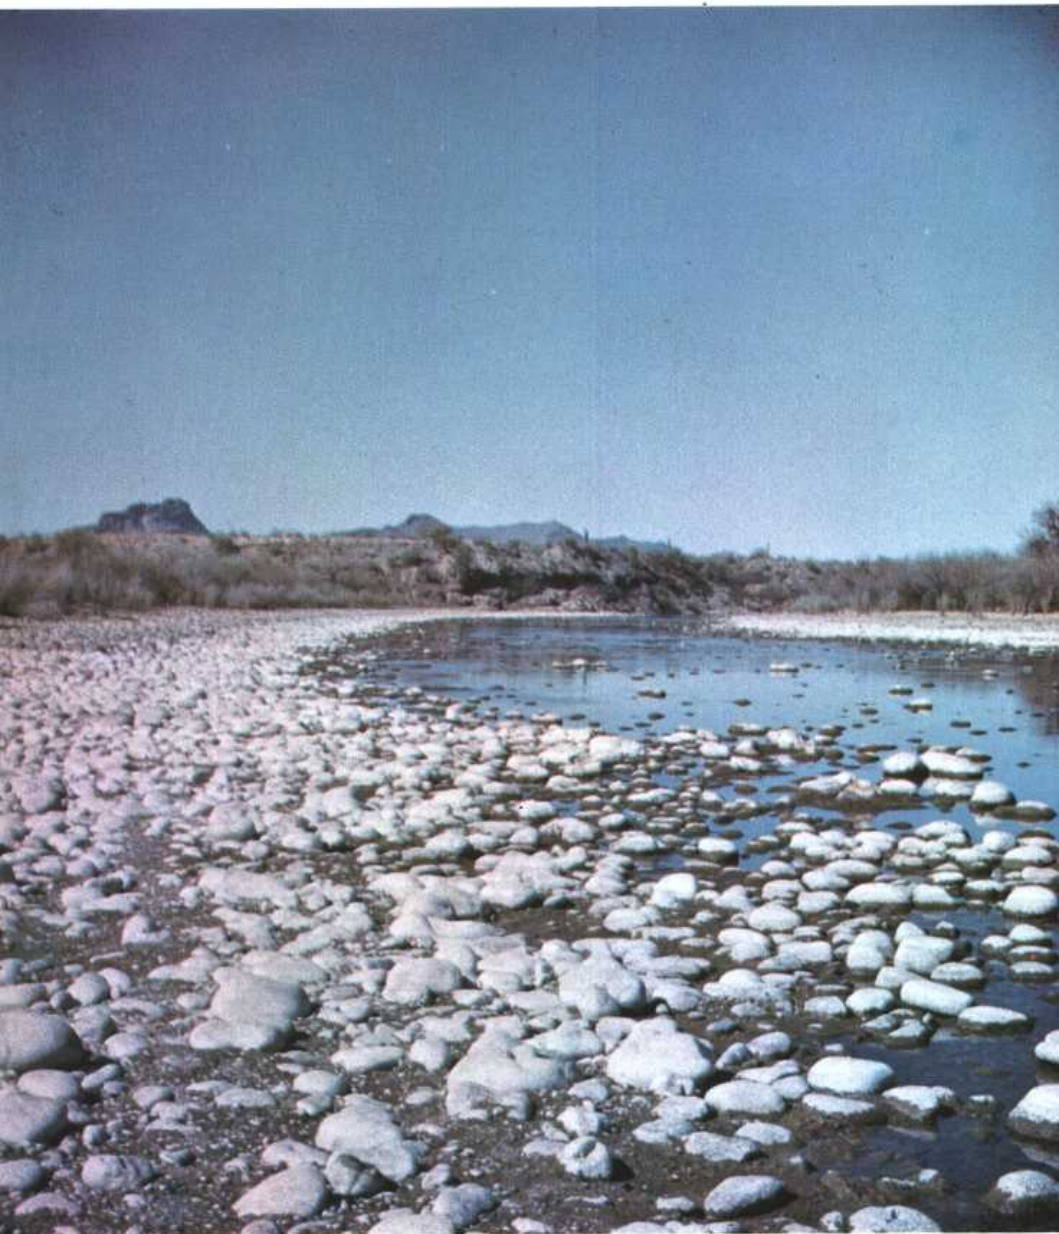
No. 818 downstream along left bank from section 2, Salt River below Stewart Mountain Dam, Ariz.
